# Rehabilitation of Bamberg Kit in the High-Voltage Lab at University of Technology-Iraq

**Abstract**—High-Voltage (HV) labs are crucial for the power and energy sector, as they provide necessary testing for power equipment and devices at voltages significantly higher than their operating levels. The Department of Electrical Engineering at the University of Technology has one of the biggest HV labs in Iraq, and it was well-equipped at some point. Unfortunately, the lab has been out of operation and neglected for decades including the Bamberg kit. No catalog nor a manual existed when the rehabilitation process started. In addition, no internet-based documentation could be found regarding the Bamberg kit due to closing the production line by the manufacturer. Thus, over the recent years, the extensive repair works were carried out and guided by practical experience, detailed analysis, and innovative problem-solving. Remarkably, these efforts were achieved with minimal costs, far below initial departmental estimations. Currently, all the HV generators in the Bamberg kit are back to its normal operation. By the end of the project, most of the kit generator circuits and measurement sys

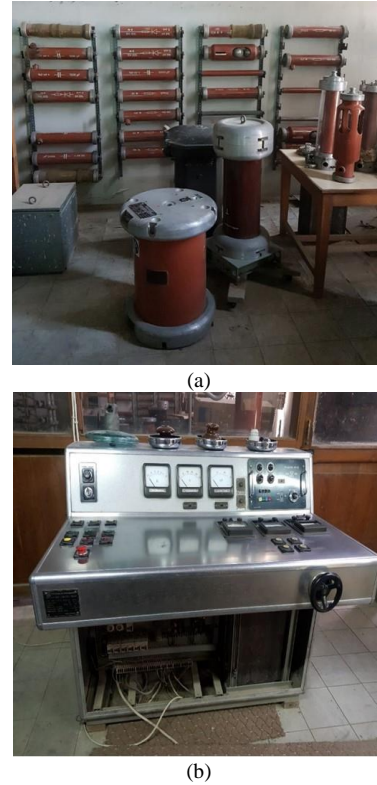
Fig. 1. Bamberg kit: (a) Components and (b) Control desk.

The Bamberg kit consists of three 0.22/100 kV AC testing transformers with all the required ancillaries, including variety of resistors, capacitors, diodes, sphere gaps and gas vessels. Photos for the kit components and its control desk are shown in Fig. 1. The kit single stage testing capabilities are 100 kV power frequency, 140 kV HVDC, and 125 kV no load impulse (max impulse). In addition, the kit is capable of generating higher voltages

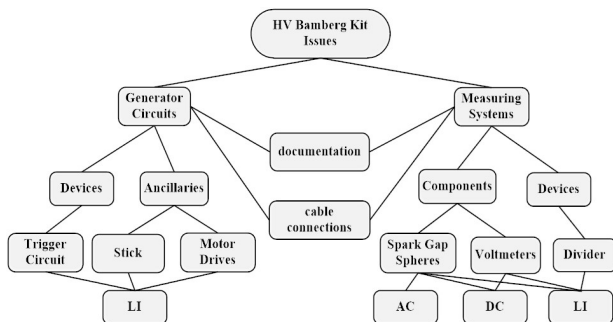
Fig. 2. Overview of key issues identified in the Bamberg Kit.

Upon the start of the HV lab rehabilitation, and with the absence of documentation, it was decided to investigate and work on each part one by one. The sequence of examinations and repairs is recommended to be followed for similar works, so each component can be examined logically in order one by one. Fig. 2 demonstrates a map for the main different issues found with the Bamberg Kit. In the following subsections, the status of each HV generator for the Bamberg kit is briefed before the rehabilitation process. Then, details for what was done to fix each issue with the generation circuit and measurement system are discussed.

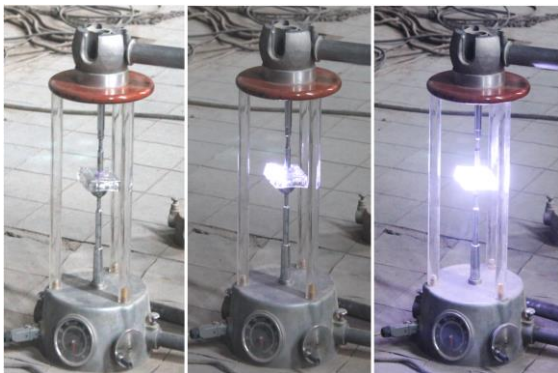
Fig. 5. Sustained arc development on a piece of glass.

Furthermore, for the cascade arrangement, due to regulation, first transformer primary current is reduced, so arc is sustained without tripping the system protection, as shown in Fig. 5.

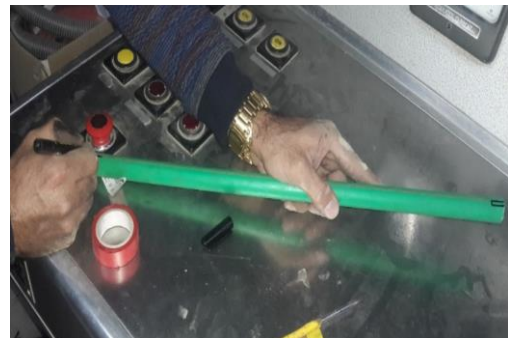
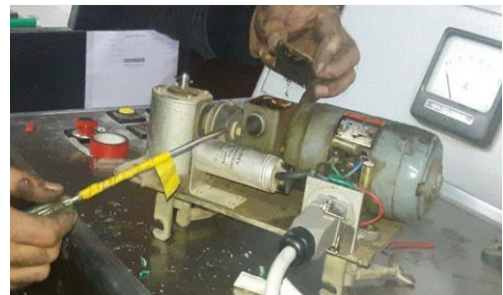
Fig. 6. Maintenance of the Bamberg Kit Lightning Impulse Single Stage Drive Motor (a) The new stick (b) drive motor.

Regarding the single stage impulse generator, many issues were found. Some of them still not solved, like the trigger control circuit, while others were addressed. The generator circuit was constructed and operated normally. This indicated that circuit components were performing properly. However, regarding the impulse sphere gap component, the stick that connects it to the motor drive could not be found in the lab. The stick transfers the rotating motion from the drive to change the gap distance. Couple of the sticks were handmade, as shown in Fig. 6 (a). Also, the drive motor for the impulse sphere gap was not responding, and it was in bad condition. Basic maintenance for the motor revived it back. In addition, replacing the three-wire connection cable and the plug and socket were also required. Finally, the drive system was restored. Fig. 6 (b) shows the maintenance work for the Bamberg kit lightning impulse drive motor.
